Use of high-resolution images to reveal the changing of Tigris river morphology by anthropogenic effect between Al-Muthanna and Sarafiya bridges – Baghdad

Asst. Prof. Halah Mohammed. S. Majeed (Ph.D.)

University of Diyala, College of Education for Humanities

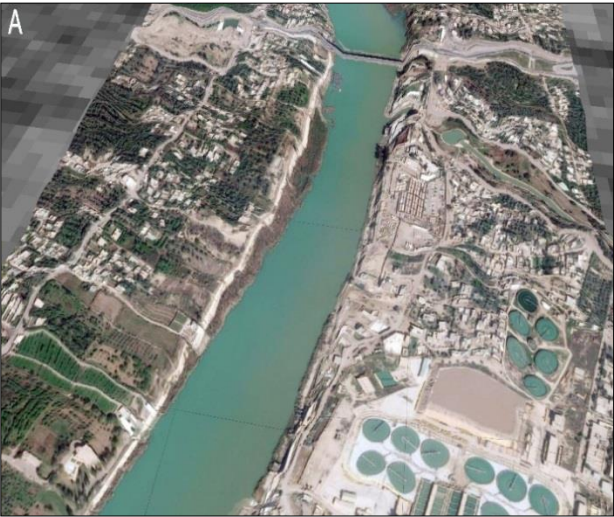
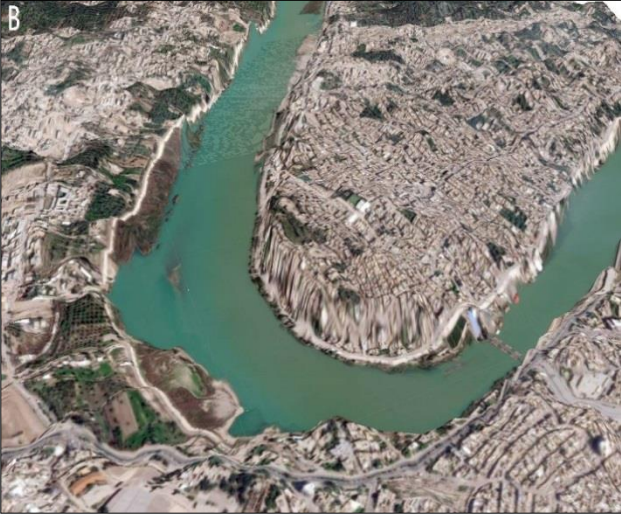
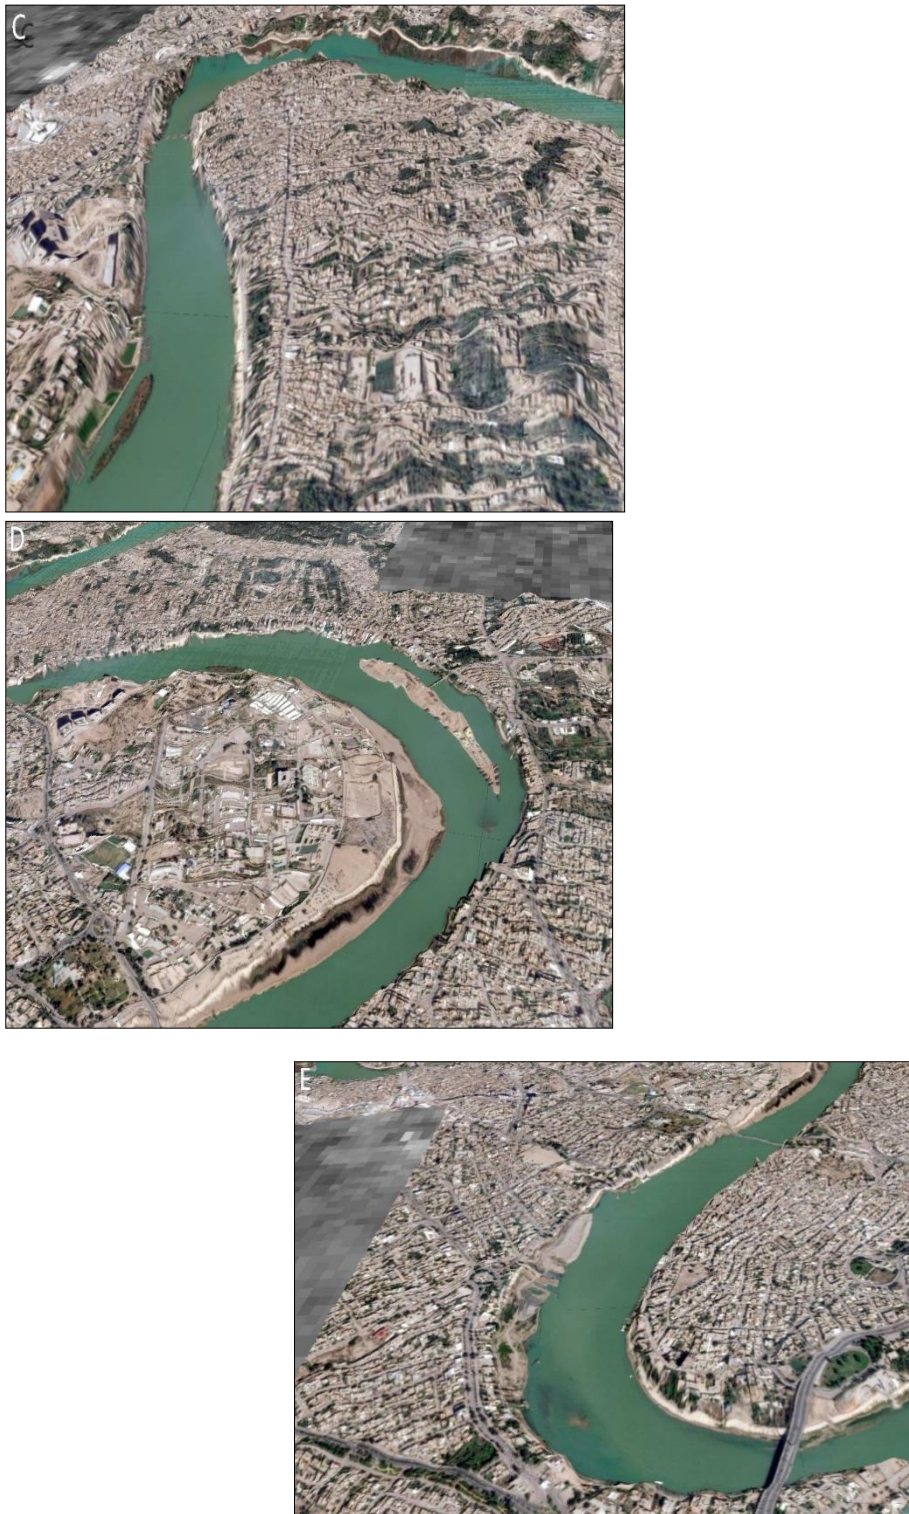
Fig (5): 3d image for selected scene in reach

right bank fig (4-A) , fig 3d (5-A) tracking inclination of this side so an longitudinal coalescence island forming at and growing taking advantage of its planting a grape and fixing an fish breeding cages photo (1-A). The proportion of change difference was (3.7m) this cause the existence of this island which mentioned above in this section, on banks of this segment observed that land use growth, agricultural use shrinks confront an active urban growth, both banks witness a riparian vegetation increasing.

4- One of the most prominent characteristics of this section is the shrinking of orchards to be replaced by urban growth, but in the right bank of the river shows the large size of the island fig (4-D) in that bank and its expansion and the emergence of many uses of land in it fig 3d (5-B) , the amount of change difference for this part is (4.36 m) due to the island located on the right bank of this section.

5- In addition to reducing the area of green cover on the banks and replacing it with extensive urban use, the most prominent characteristic of this sector of the river is the formation and rapid formation of the conjunctivitis islands for the two banks due to the construction of the floating bridge in this area fig (4-E) fig 3d (5-B) , the amount of change difference in this section was (50.40 m).

6- There is an active and dense urban expansion that has replaced the green cover with an island conjoined on the left side of the riverbank, and in 2020 the land uses on this island varied fig (4-E) fig 3d (5-C), the amount of change was (85.34 m).

movement of this expansion to the opposite island and near this bank and the investment of the island as recreation areas and restaurants as this island in the left Bank fig (4-G) fig 3d (5-D) photo (1-B,C) , was linked to the construction of a road with long 132 meters , the amount of change difference is (26.18 m)

8- The most prominent feature of this section is the presence of the Imams Bridge as well as the replacement of the green cover with residential use and the presence of a strip of conjunctivitis deposits in the right Bank in this area fig (4-H) fig 3d (5-D), the amount of change difference for this section was (13.62 m)

9- In this section there is a clear deposition of sediments on the right bank, and the islands are formed and developed on this side fig (4-I) fig 3d (5-D), with a change variation of (-42 m) for human modifications on the island for exploitation.

10- This section shows a shrinking vegetation cover for general , A multi-function working boat working on left bank so a anew sedimentation islands appear on two banks fig (4-J) fig 3d (5-D) photo (1-D) , the magnitude of change variation in this part of the river is (-81.45) due to river training works in right bank.

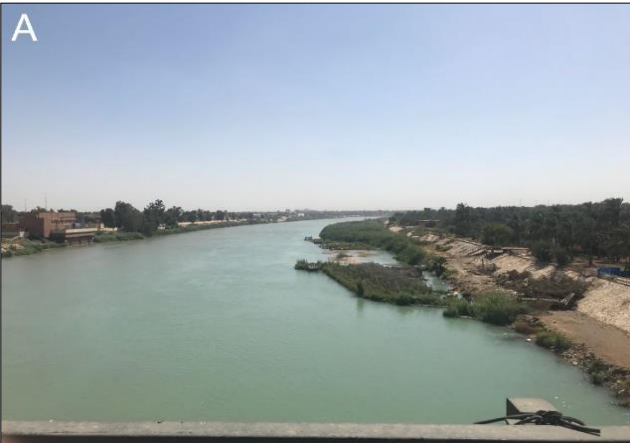
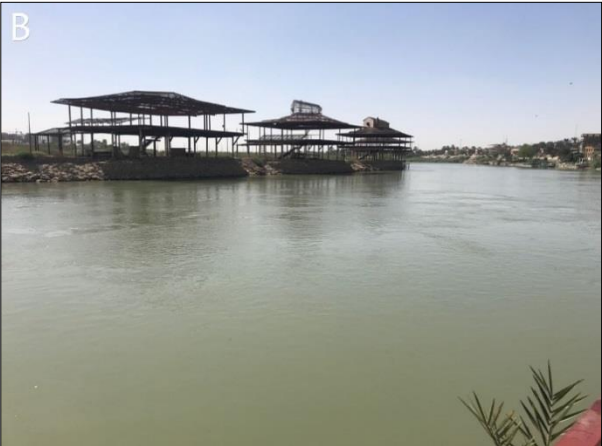
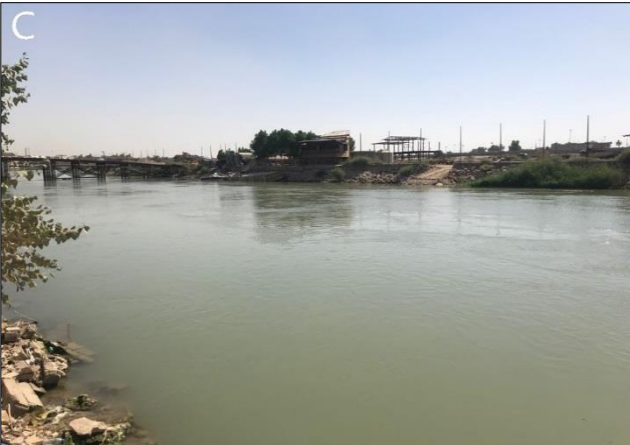
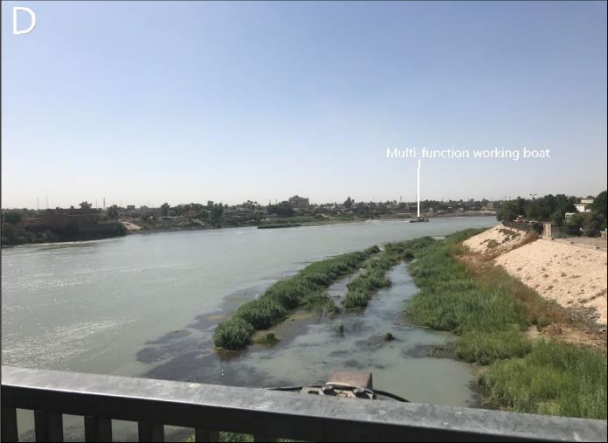
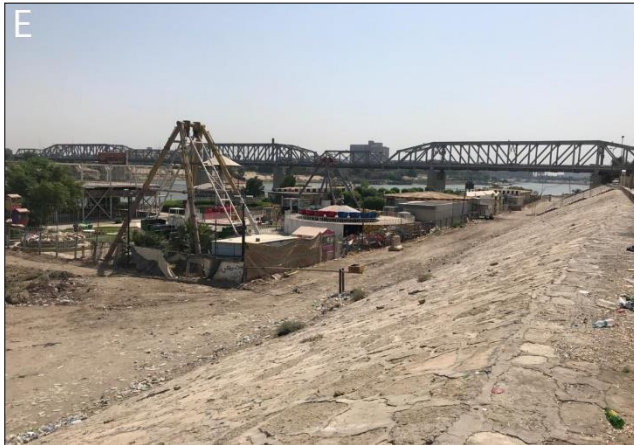
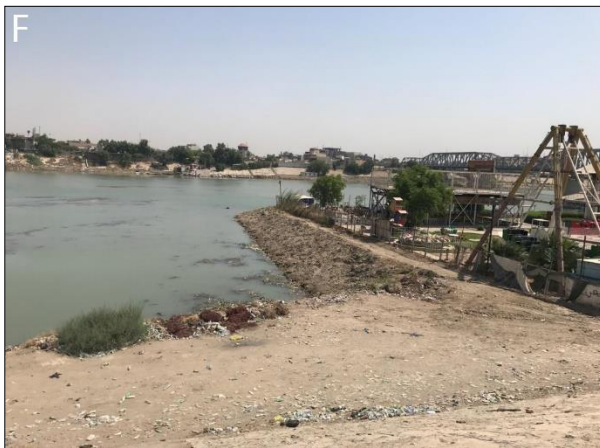
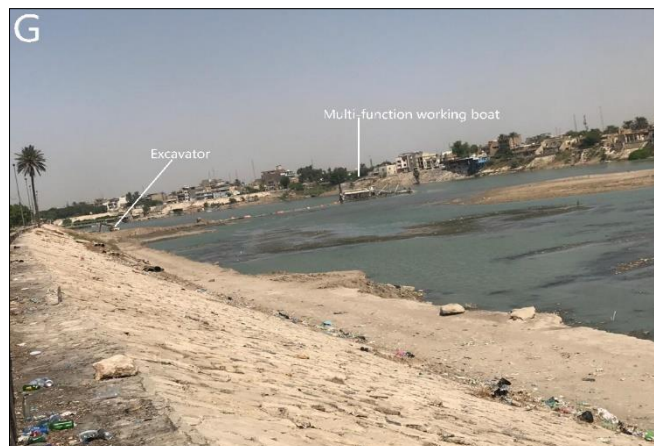
Photo (1): photos depict many human activities in reach (15-18/9/2021)

12- In the last section there is a clear formation of the island on the left bank of the river, but a large part of it has been removed and specific parts been kept to use as a restaurant and a boat moorage, fig (4-L) fig photo (1-E,F) the difference of change is (-82.43m).
